Confidential Inspection Report

**Property Inspected:
1234 North South Street, Twin Cities, , MN**

**Client:
Mr. & Mrs. Doe**

**Prepared by:
Heartland Inspections, Inc.
(612) 961-3306
www.heartlandinspections.com
info@heartlandinspections.com**

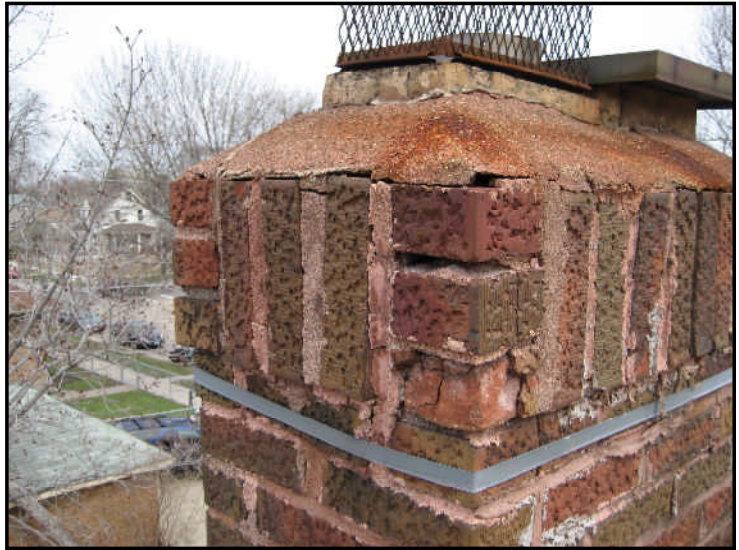
Condition: Loose brick, deteriorated mortar, cracks in covering cap. Recommend repair by chimney technician. We recommend installing proper rain/pest caps on top of chimney.

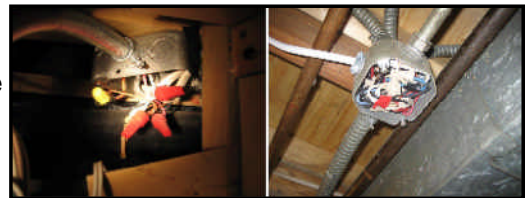
Romex (Non metallic, plastic jacket wiring)
Conduit (metal or plastic), 110 volt circuits are fed by copper wire. 220 volt circuits are fed with both copper and aluminum wires. Either wire type is normal for 220 volt circuits. [We saw open junction boxes that should have proper covers installed for safety.](#)

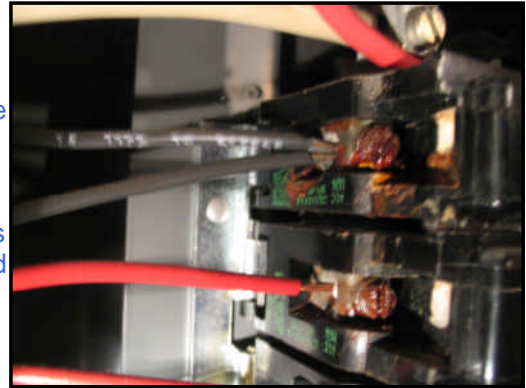
Corrosion observed in the electrical panel. Corroded electrical components are improper and should be corrected by a licensed electrician. Some wires are double tapped (more than one wire to a terminal). With few exceptions, this is not generally considered good practice. Most devices are designed for single wire attachment and it is difficult to be certain that the contact is good if multiple wires are attached. Consult a licensed electrician for correction.

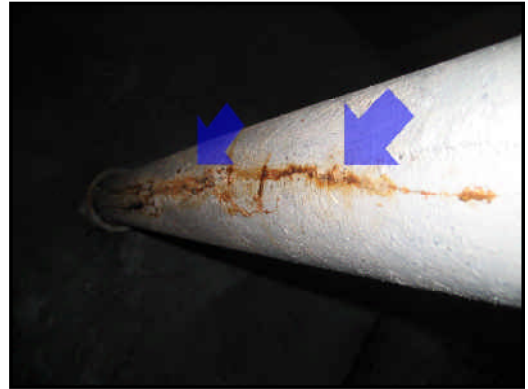
Condition: Rusted or corroded pipes were observed which are in need of repair.

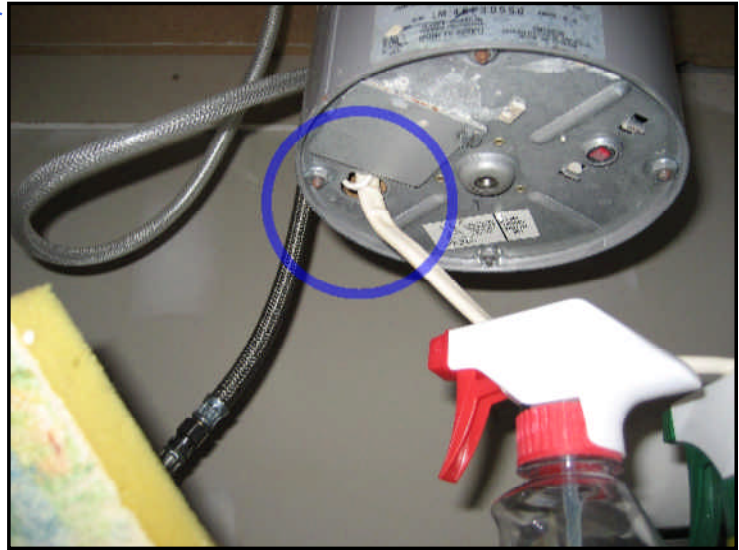
Condition: Wire clamp is improper or missing on electrical connection, repair by electrician recommended for safety.

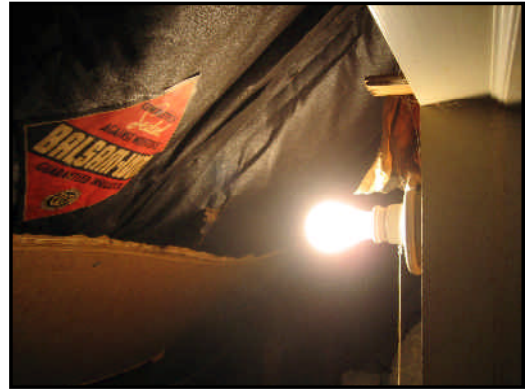
Light fixture(s) observed which are located too close to combustibile material. Correction by electrician recommended for improved safety.
