Confidential Inspection Report

**Property Inspected:
1234 North South Street, Twin Cities, , MN**

**Client:
Mr. & Mrs. Doe**

DATE: December 11, 2010
TO: Mr. & Mrs. Doe
RE: 1234 North South Street, Twin Cities,

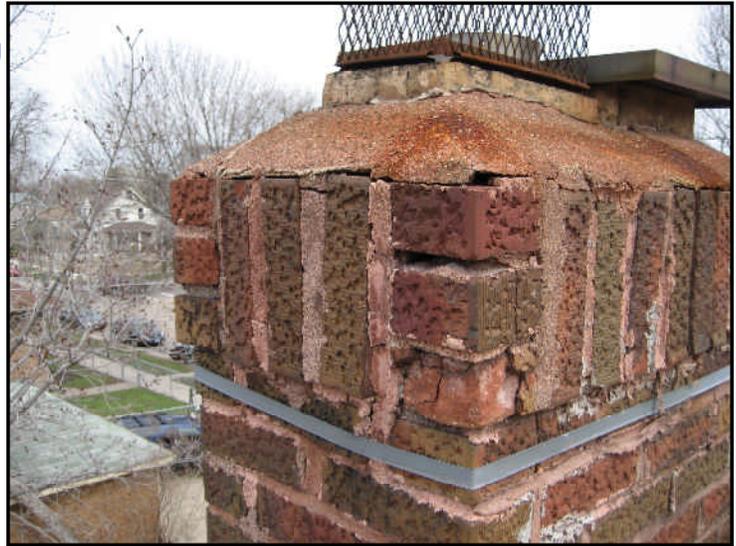
4. Loose brick, deteriorated mortar, cracks in covering cap. Recommend repair by chimney technician. We recommend installing proper rain/pest caps on top of chimney.

Condition: Loose brick, deteriorated mortar, cracks in covering cap. Recommend repair by chimney technician. We recommend installing proper rain/pest caps on top of chimney.

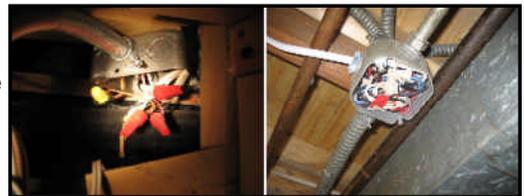
10. We saw open junction boxes that should have proper covers installed for safety.

Romex (Non metallic, plastic jacket wiring)
Conduit (metal or plastic), 110 volt circuits are fed by copper wire. 220 volt circuits are fed with both copper and aluminum wires. Either wire type is normal for 220 volt circuits. [We saw open junction boxes that should have proper covers installed for safety.](#)

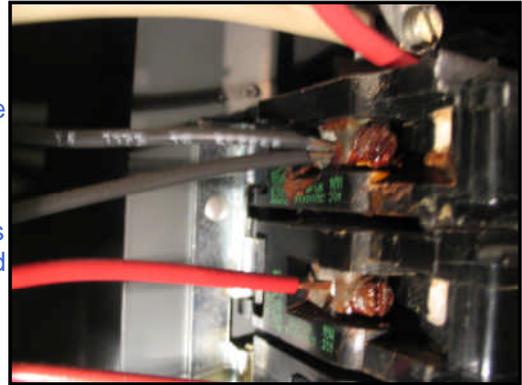
11. Corrosion observed in the electrical panel. Corroded electrical components are improper and should be corrected by a licensed electrician. Some wires are double tapped (more than one wire to a terminal). With few exceptions, this is not generally considered good practice. Most devices are designed for single wire attachment and it is difficult to be certain that the contact is good if multiple wires are attached. Consult a licensed electrician for correction.

Corrosion observed in the electrical panel. Corroded electrical components are improper and should be corrected by a licensed electrician. Some wires are double tapped (more than one wire to a terminal). With few exceptions, this is not generally considered good practice. Most devices are designed for single wire attachment and it is difficult to be certain that the contact is good if multiple wires are attached. Consult a licensed electrician for correction.

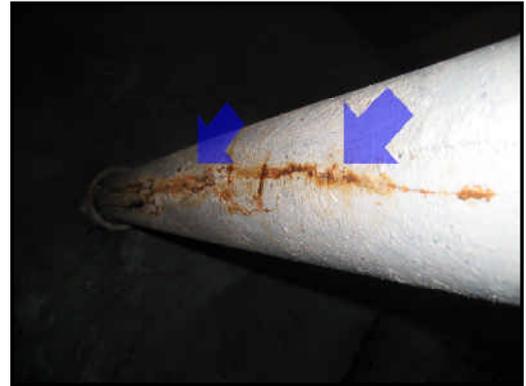
13. Rusted or corroded pipes were observed which are in need of repair.

Condition: Rusted or corroded pipes were observed which are in need of repair.

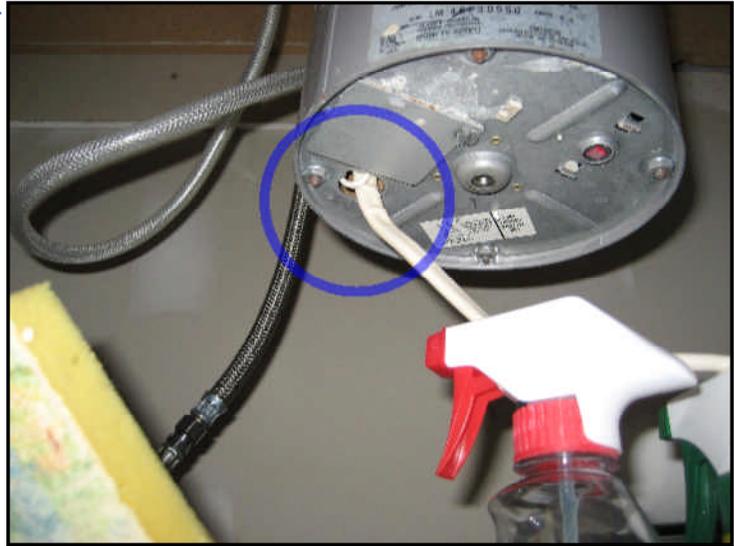
16. Wire clamp is improper or missing on electrical connection, repair by electrician recommended for safety.

Condition: Wire clamp is improper or missing on electrical connection, repair by electrician recommended for safety.

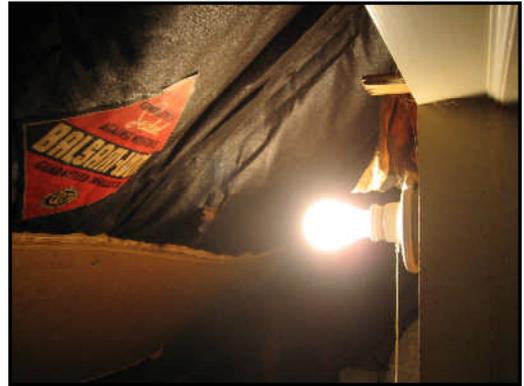
21. Light fixture(s) observed which are located too close to combustible material. Correction by electrician recommended for improved safety.

Light fixture(s) observed which are located too close to combustibile material. Correction by electrician recommended for improved safety.
