# Confidential Inspection Report

1234 Satisfaction Avenue

Monday, April 29, 2019

Inspector, Nick Koenig ASHI# 259093  
Heartland Inspections

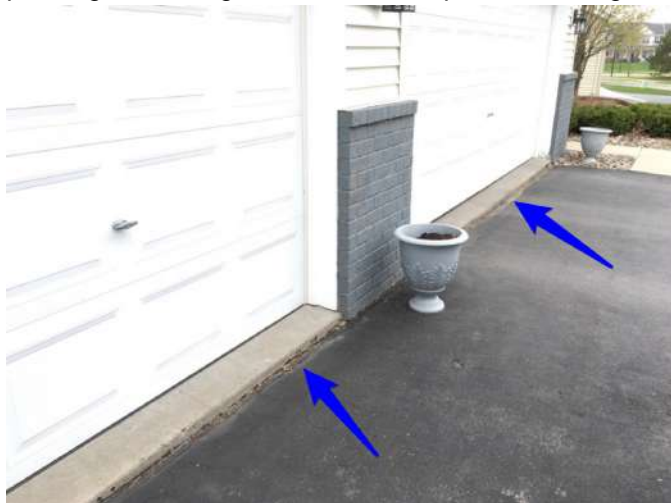
**16:** There is settling where the driveway meets the garage. Recommend this be repaired to prevent water ponding or soaking in and correct or prevent damage to foundation below.

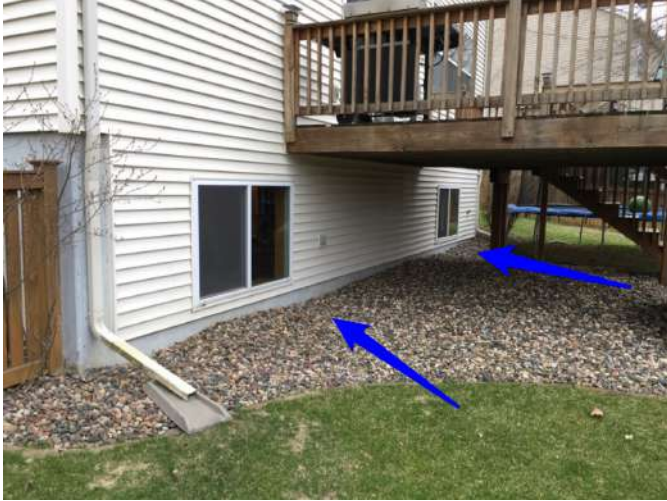
**UPG 20:** Portions of the area surrounding the house do not appear to slope away from the foundation. This should be improved so that the earth slopes away approximately 1/2" per foot for about 10 feet. This does not insure the basement will be dry, but it is an important first step. Keeping any basement 100% dry can be very difficult, they are not designed like a boat. Maintaining proper grading, installing and maintaining gutters with long downspouts will certainly improve the odds.

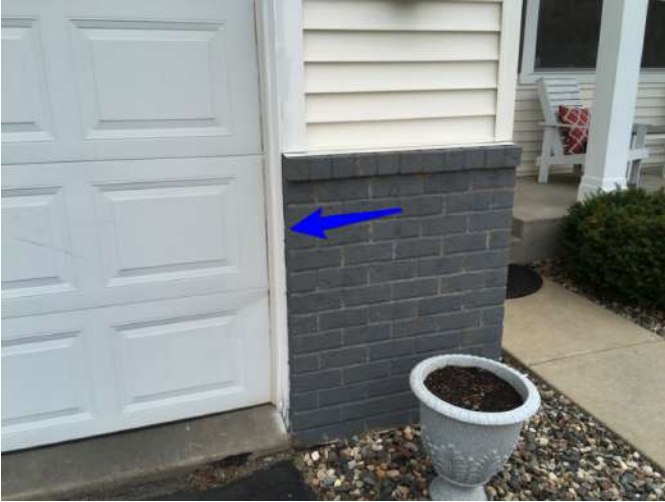
**REPR 24:** Caulking maintenance is needed. Gaps in siding or between the siding and trim observed. Routine maintenance of caulking all openings is necessary to prevent water entry.

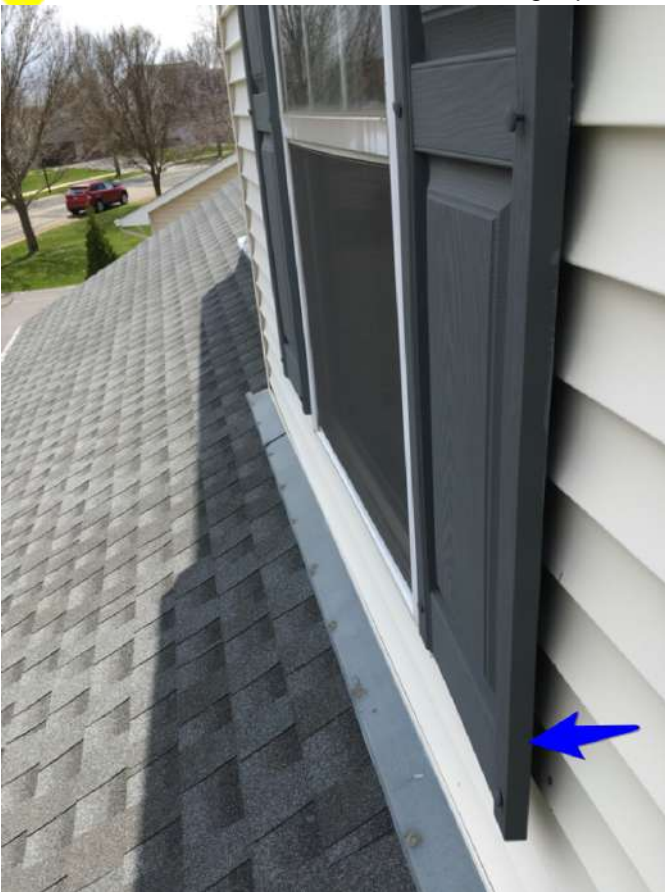
**REPR 25:** Loose shutter. Recommend securing/repair.

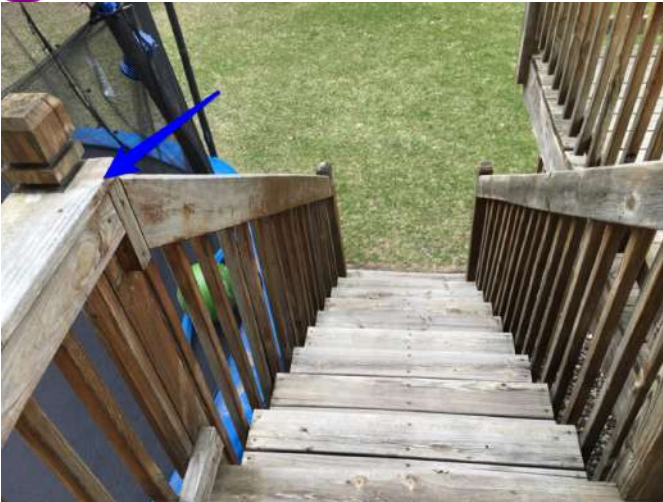
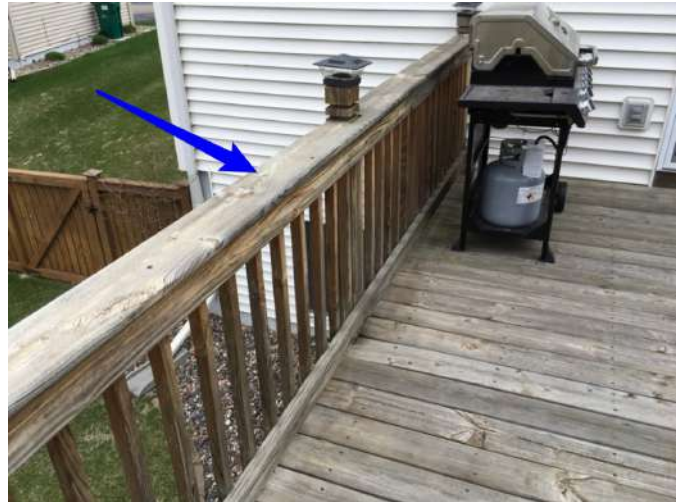
**s-32:** Loose railing, upgrade for safety.

**SFTY 32:** Loose railing, upgrade for safety.

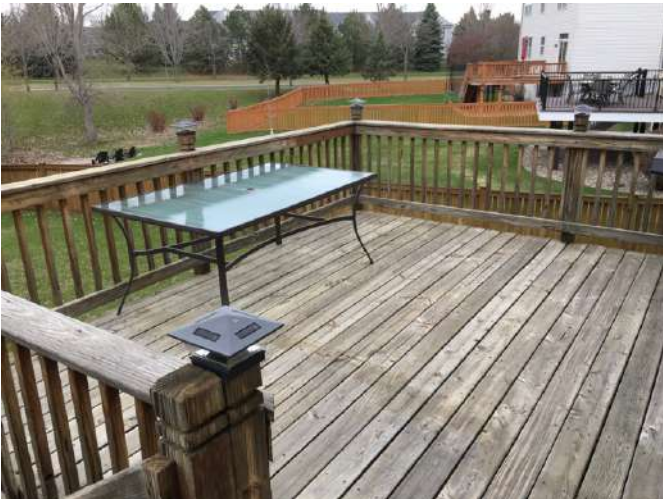
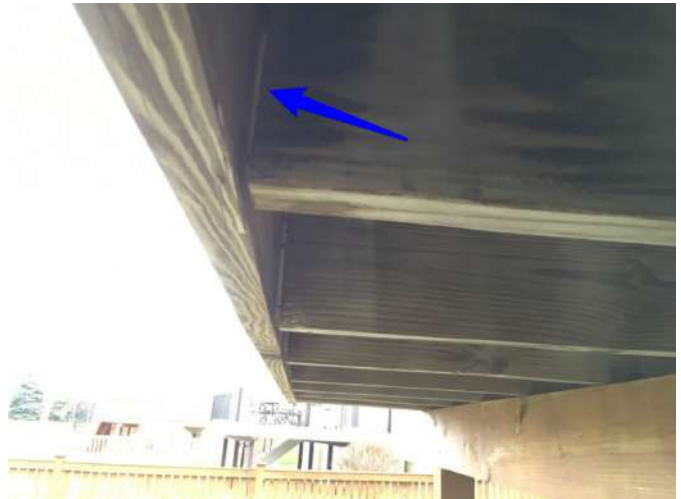
**s-33:** The decks can sway side to side-(racking), recommend strengthening the deck, consult with a qualified contractor for repairs/upgrade.

**REPR 33:** The decks can sway side to side-(racking), recommend strengthening the deck, consult with a qualified contractor for repairs/upgrade.

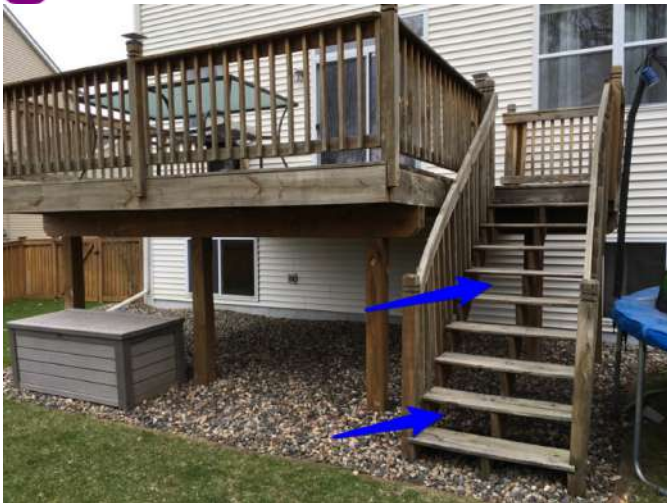
**SFTY** 34: Open risers, recommend enclosing the risers for safety.

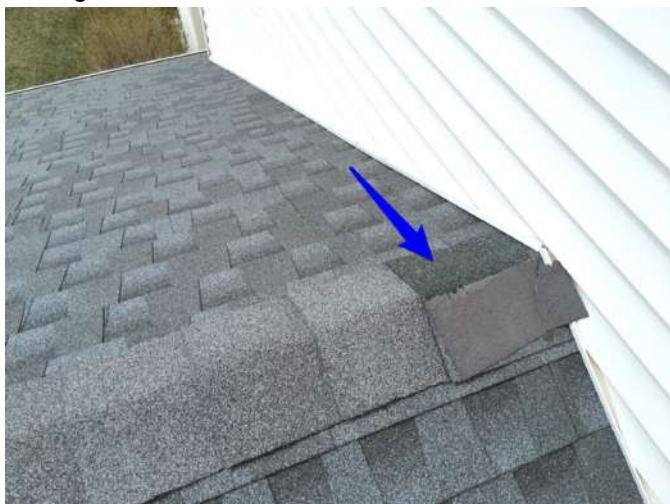
**REPR 41:** Damage/Deterioration/Defects noted. Missing or damaged areas need to be repaired by a competent roofing contractor.

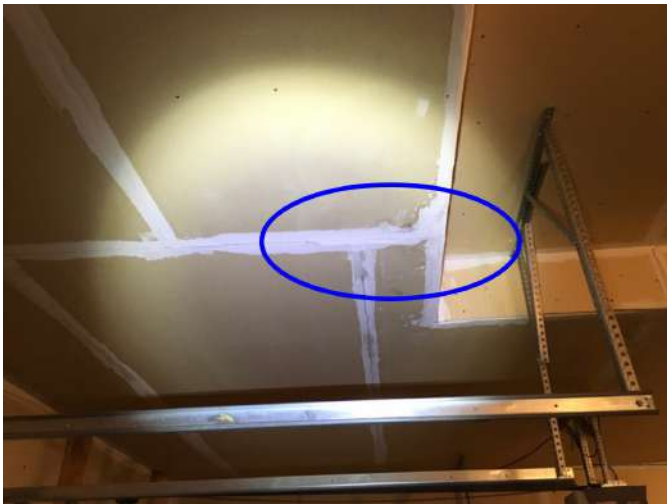
**MNTR** **INFO** 51: Moisture stains visible. Ask seller for details on all stains. It is possible that there may be hidden damage associated with these stains.

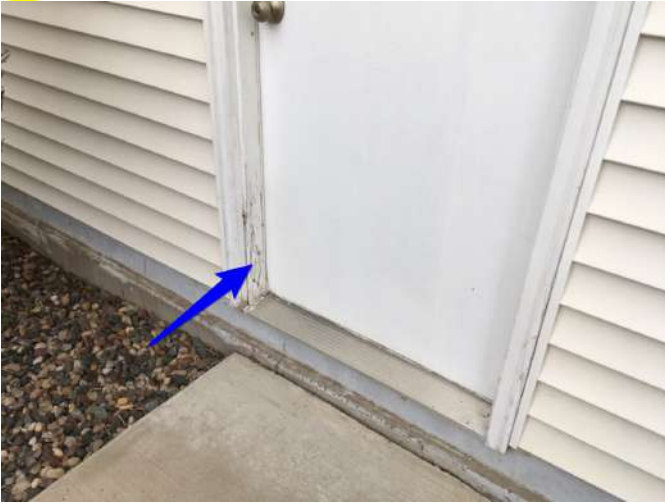
**REPR** 53: Decay in lower jamb/trim/threshold, repair recommended.

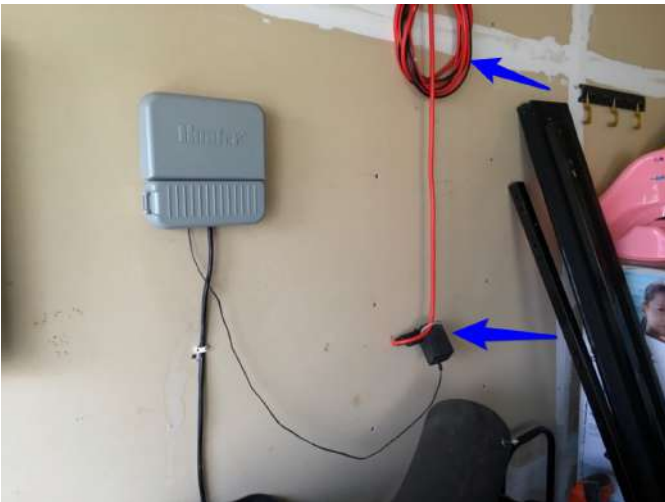
**UPG** 56: Extension cords are in use in place of permanent wiring. This is frequently found to lights and garage door openers. Any long term use should be served by a proper local outlet reachable by the manufacturers installed cord. Contact an electrician for installing additional outlet(s).

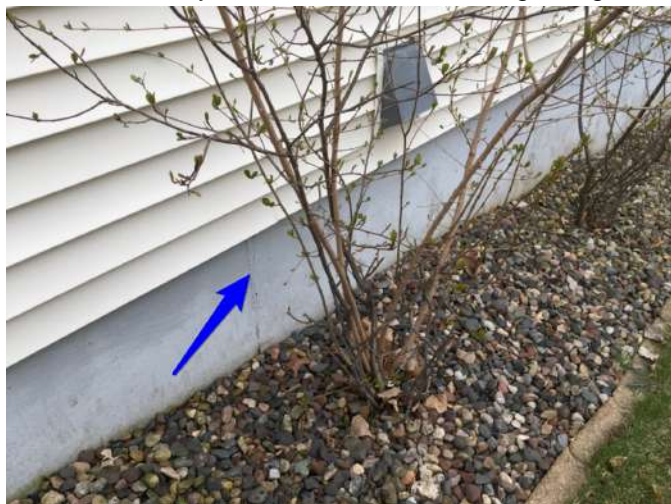
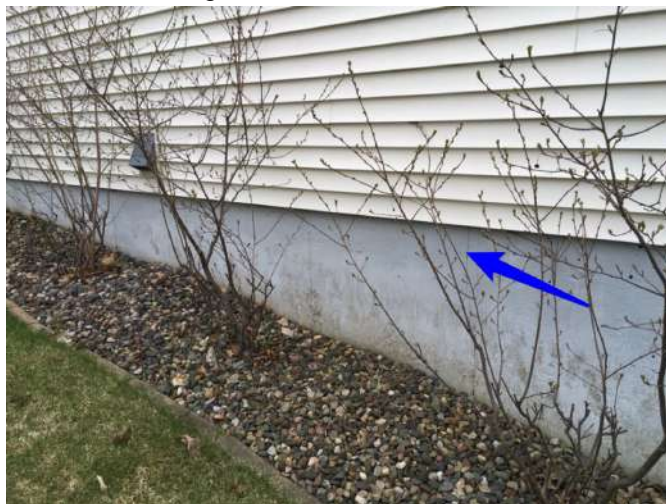
**EVAL** 65: Cracks observed in the foundation walls which are less than 1/4" in width. Generally not a major concern, we recommend you consult a contractor regarding the best method of dealing with these cracks.

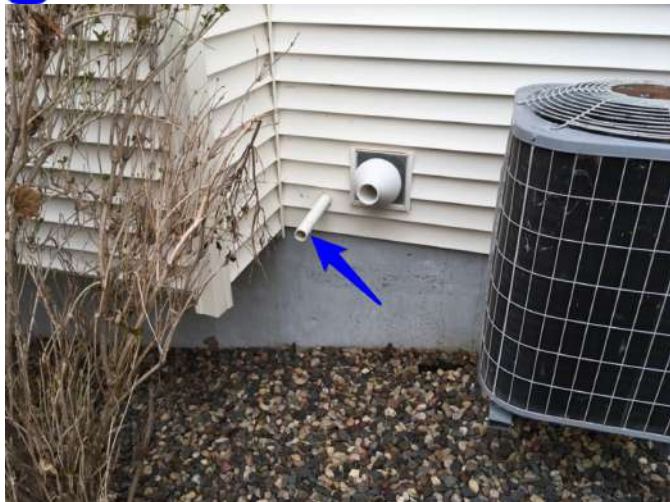
77: The exterior discharge needs to be extended away from the foundation so water does not recycle.

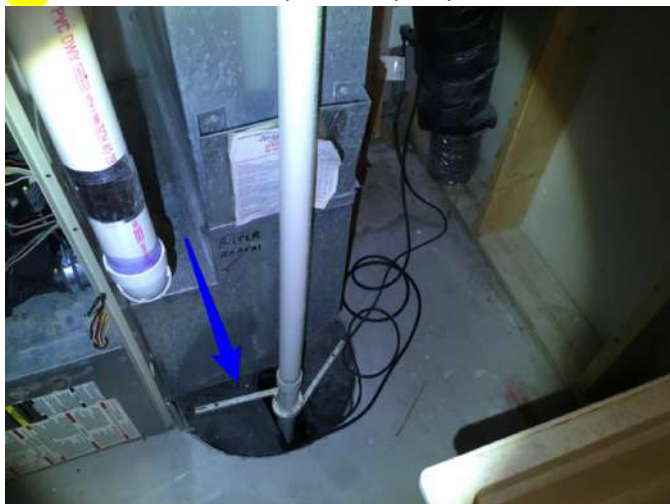
78: Note: The sump basket/pump is difficult to access. Recommend improvements.

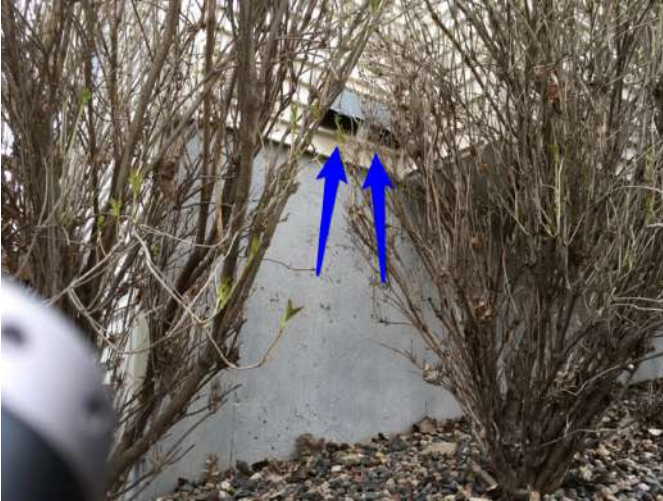
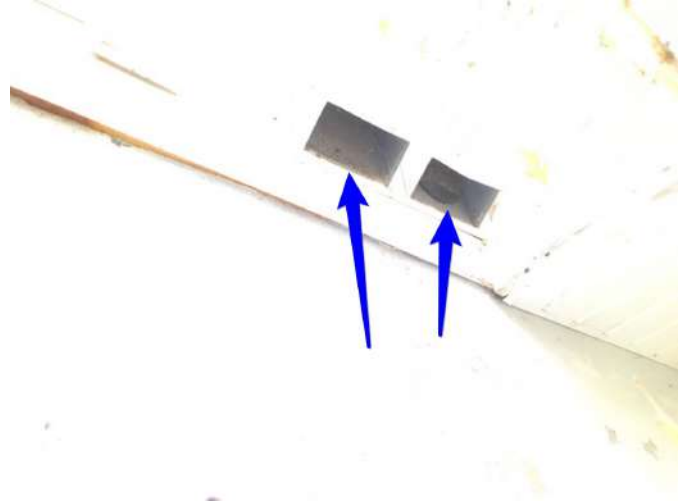
**REPR** 86: The combustion air supply is dirty. Clean the intake grill at the exterior regularly, consult a heating contractor if you do not know where this grill is. Remove any other obstructions to air flow. The intake must not be located in an inaccessible area.

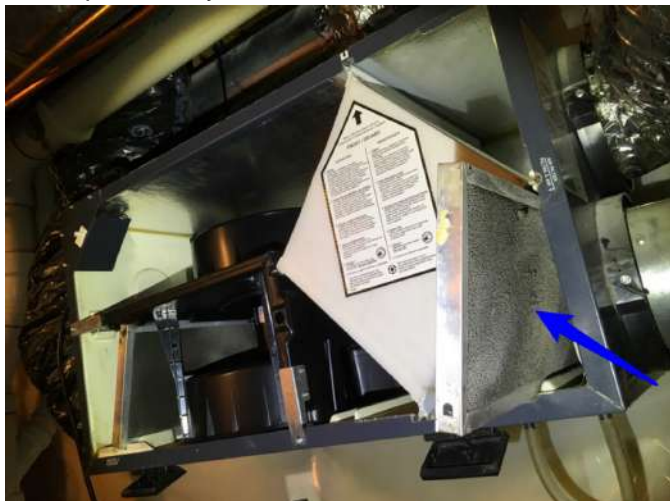
**REPR 94:** The filters are dirty. Recommend servicing per manufacturers instructions. Remember to clean the exterior intake periodically.

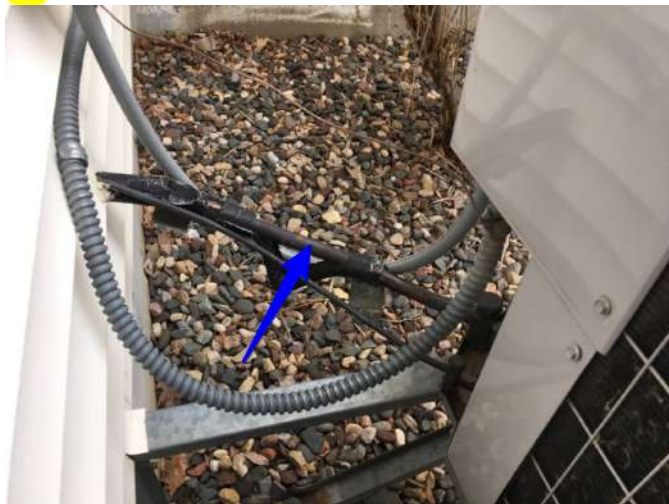
**107:** The insulation on the freon tube needs repair or replacement.

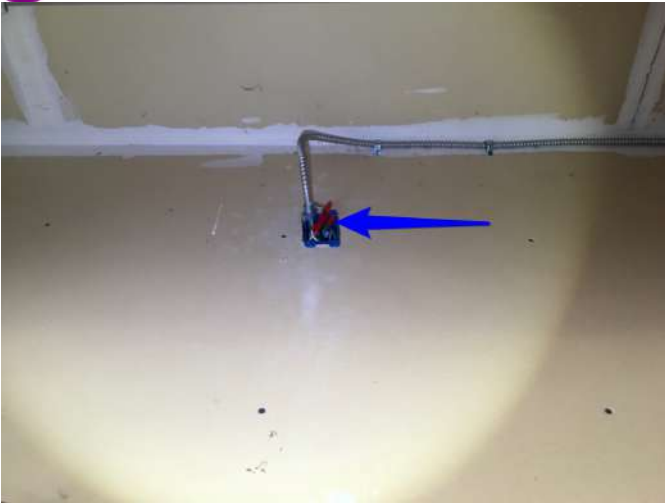
Garage

**s-117:** We saw open junction boxes that should have proper covers installed for safety.

**117:** We saw open junction boxes that should have proper covers installed for safety.

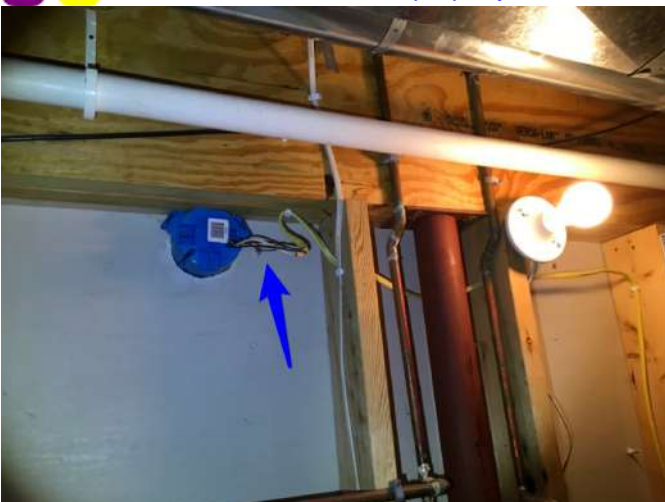
Mechanical room

**s-118:** Some cables are improperly run, attached or protected, recommend repair by a qualified electrician.

**118:** Some cables are improperly run, attached or protected, recommend repair by a qualified electrician.

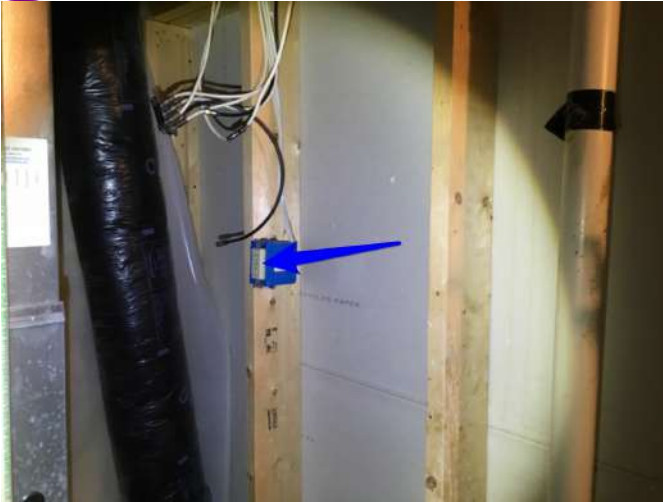
Mechanical room

**SFTY 119:** Missing or damaged cover plates observed, install plates to prevent contact with live electrical parts.

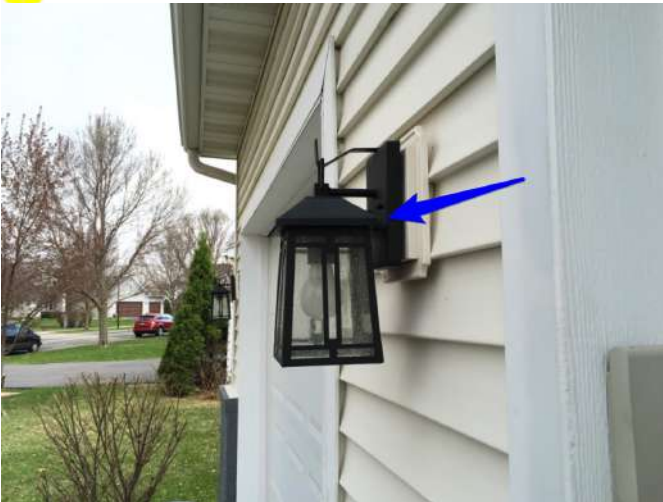
**REPR 121:** Light fixture observed which was not properly secured. This should be corrected by an electrician.

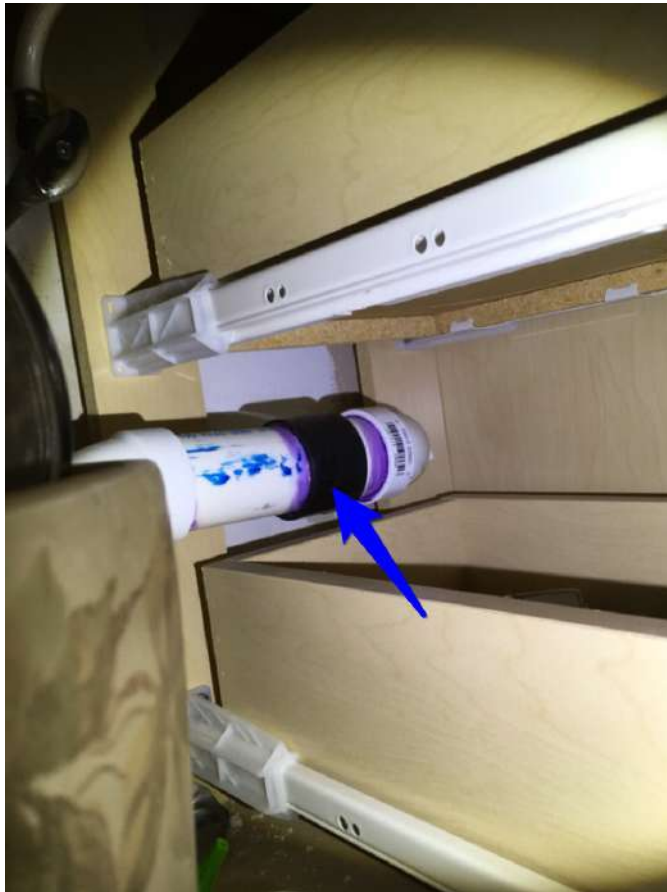
Basement bathroom sink

**MINTR** **133:** Some improper joining of ABS (Black) and PVC (white) waste piping. These materials are generally not compatible and should be monitored for leaks.

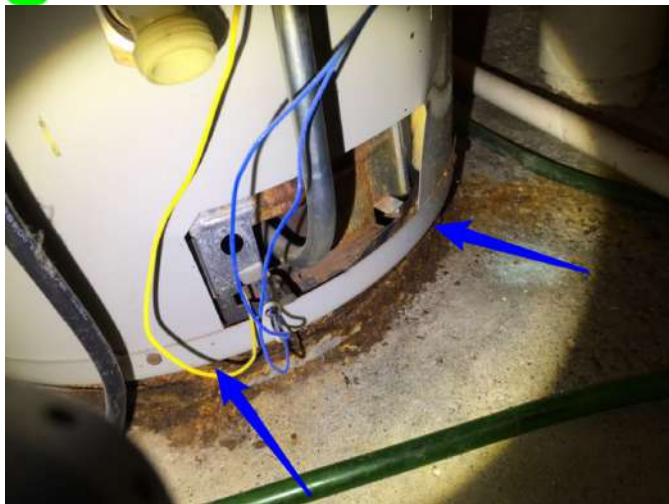
**s-143:** Due to the age of this heater and generally expected lifespan, we recommend you be prepared to replace it in the near future.

**s-144:** Corrosion observed on water heater. Anticipate replacement.

**EVAL** 144: Corrosion observed on water heater. Anticipate replacement.

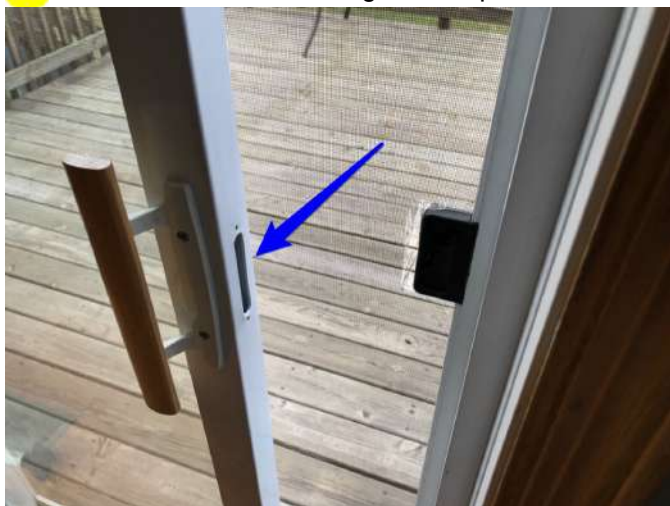
**REPR** 149: Doesn't latch/missing latch, repair recommended.

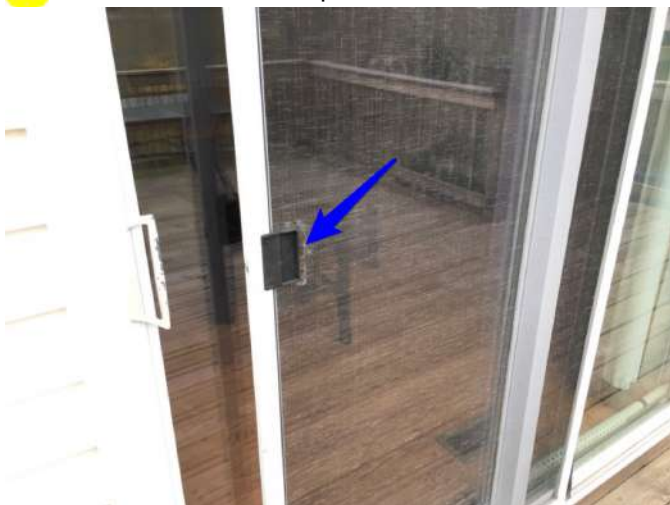
**REPR** 150: Screen needs repairs.

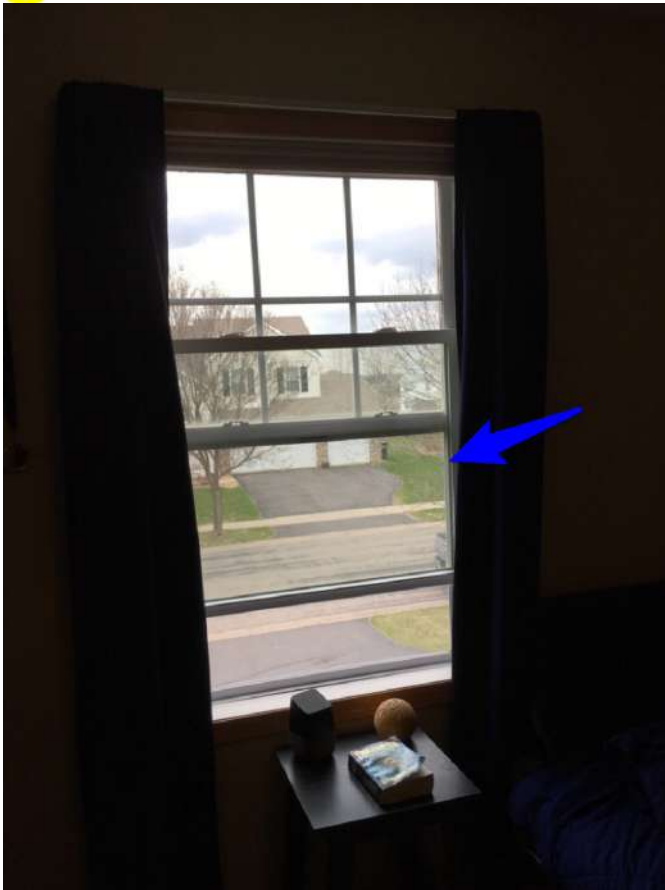
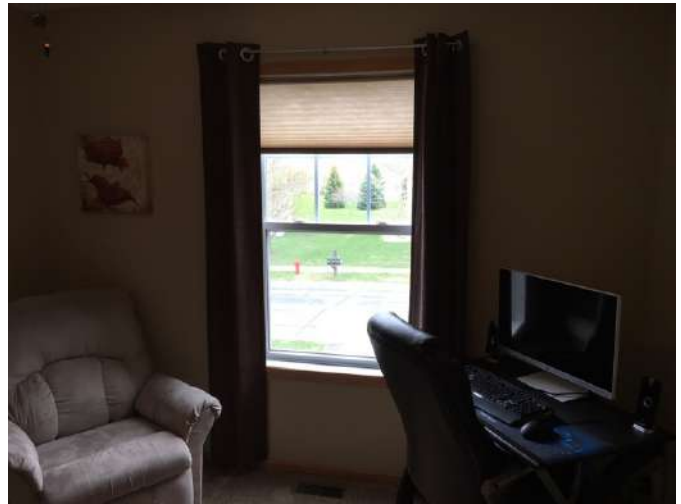
**REPR** 153: Some windows are hard to operate. Recommend adjustments.

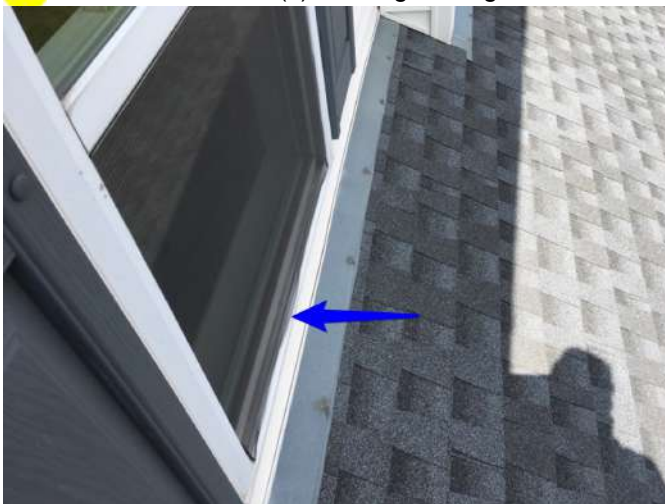
Upper front bedroom

**REPR** 154: Note: Screen(s) missing/damaged.

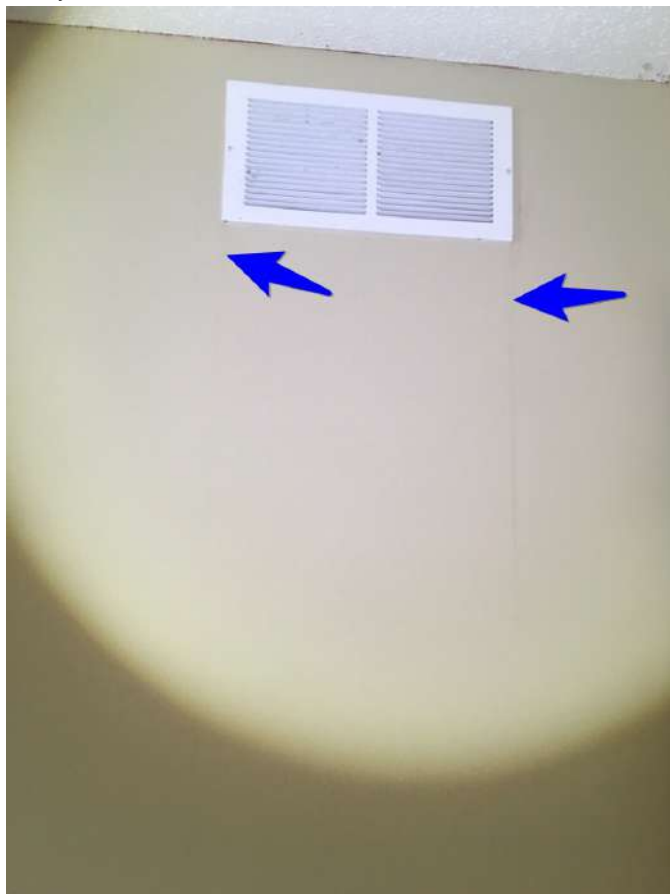
Upper rear left bedroom

**158:** Stains observed on wall(s). Request information from the sellers regarding the history of stains and what if any action has been taken. The cause should be determined and corrective measures taken if needed.

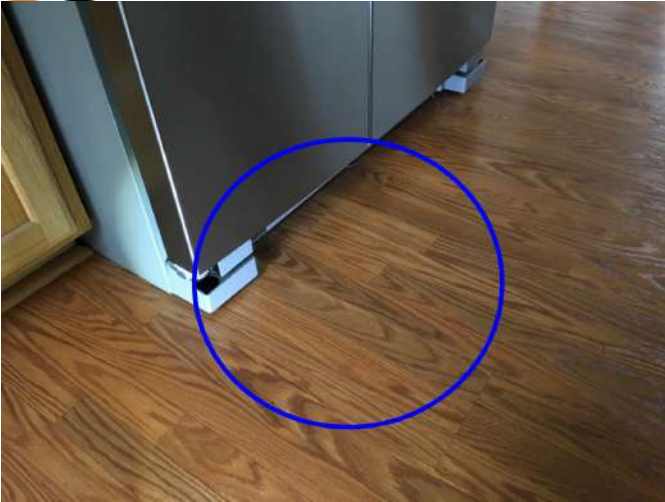
**163:** Damage/deterioration is noted. The refrigerator may of leaked. Ask seller for details.

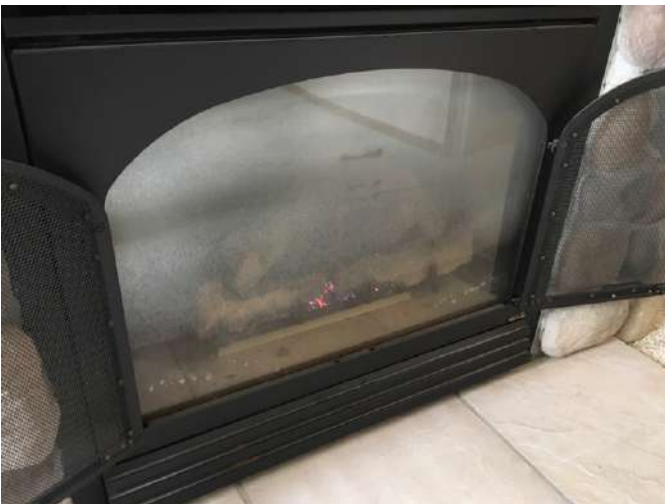
**168:** The glass front shows deposits on the inner surface which should be cleaned off. These deposits may become permanent with time. We can not tell if they will come off or not. If they do not come off and you want them gone, glass replacement may be needed (possibly several hundred dollars).

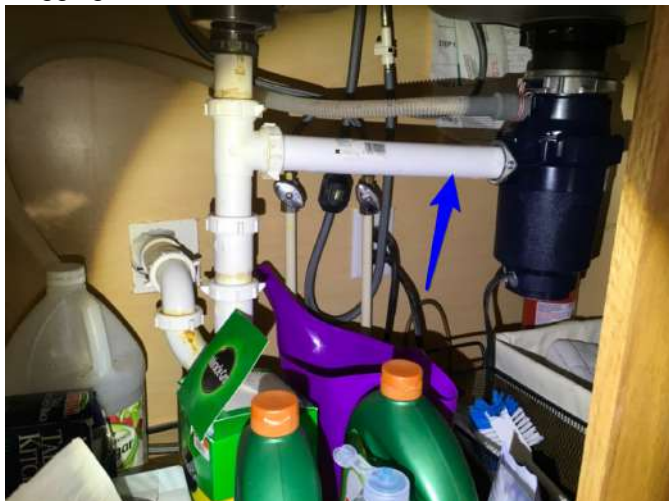
Kitchen

**REPR** **182:** Pipes were observed which do not have sufficient slope for proper drainage. This may result in pipes clogging and increased maintenance if not corrected. Recommend repair.

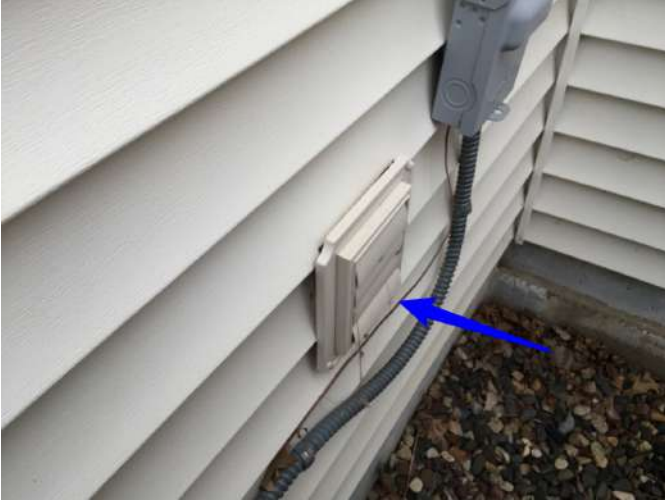
**REPR** **193:** The dryer has a louvered vent at the exterior. They have a tendency to build up lint. Recommend converting to a standard hood with flapper.

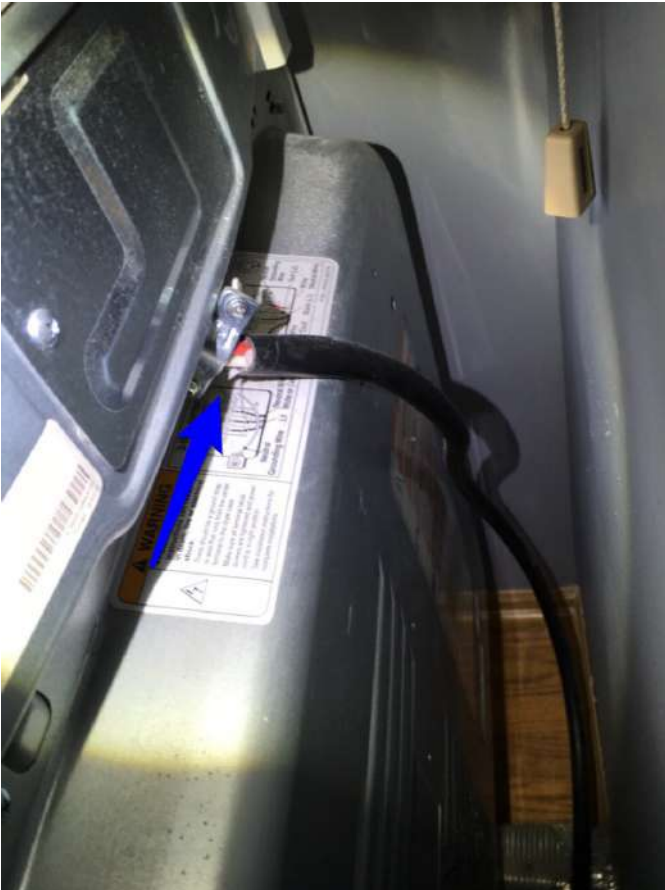
**SFTY** **REPR** **194:** The strain relief clamp is loose/missing where the electrical cord enters the dryer, recommend repair by a qualified electrician.

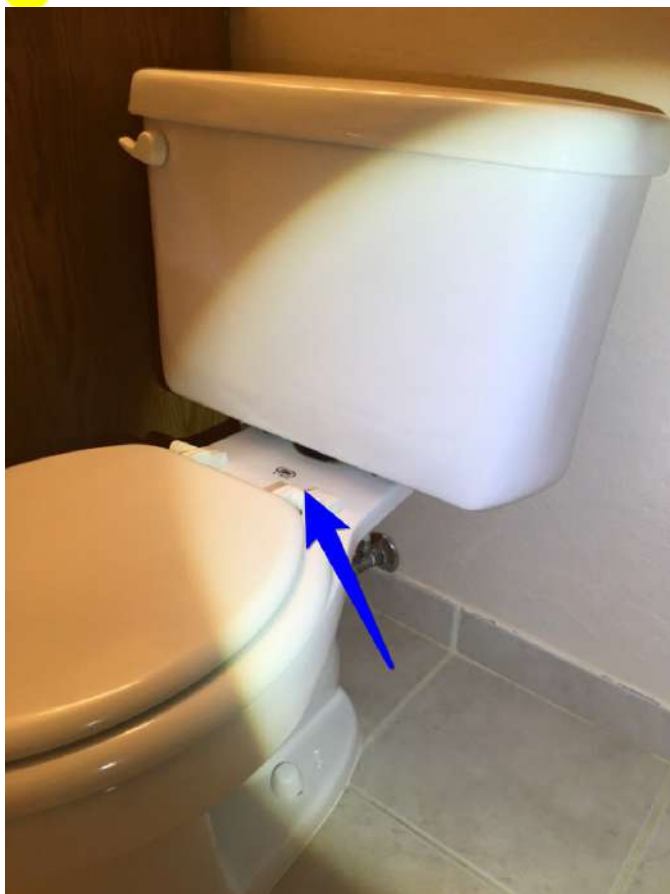
**REPR** **202:** Toilet tank is loose at the toilet bowl. Recommend repair.

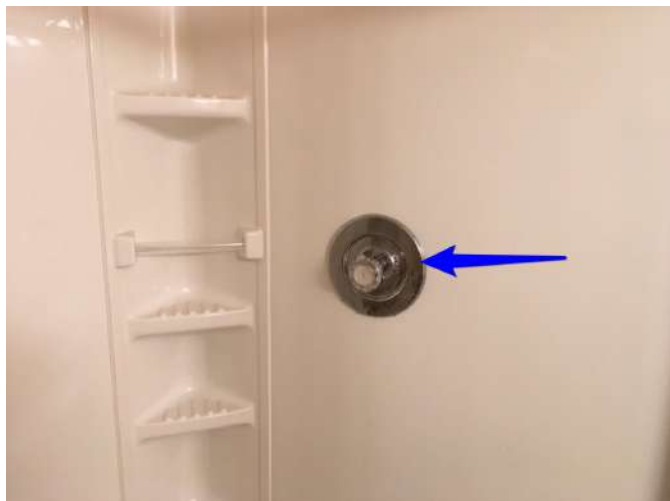
**REPR 205:** Hot and cold controls are reversed. Cold water should be controlled by the right side. Potential scald hazard.

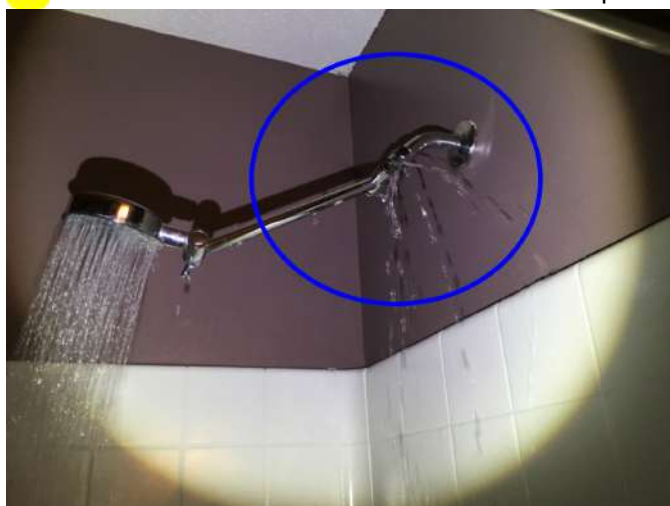
**REPR** **223:** The shower head leaks. Recommend repair.

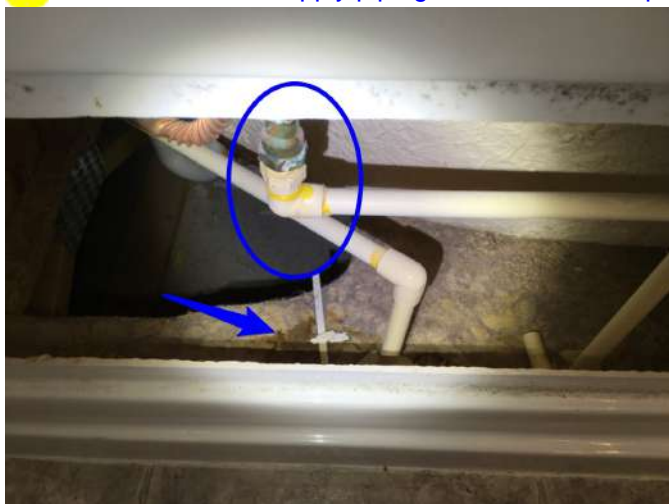
**s-236:** Leak on the supply piping below the tub. Repairs needed.

**REPR** **236:** Leak on the supply piping below the tub. Repairs needed.

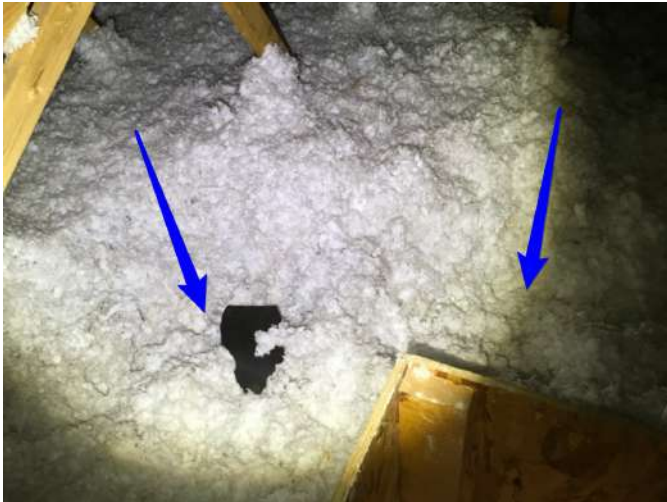
**243:** Some insulation is uneven. Re-spreading/adding insulation is recommended to provide more consistent coverage.
